# Asbestos Management Survey Report

23- 34 Amber Court 3 (Communal Areas), Swindon, SN1 2HB

**SWINDON ASBESTOS SURVEYING LTD**

Date of Survey:	24 Aug 2022
Date of Report:	5 Sep 2022
Job No:	<u>J011787</u>
Authorising Surveyor:	Jim Hook
Verified/Signature:

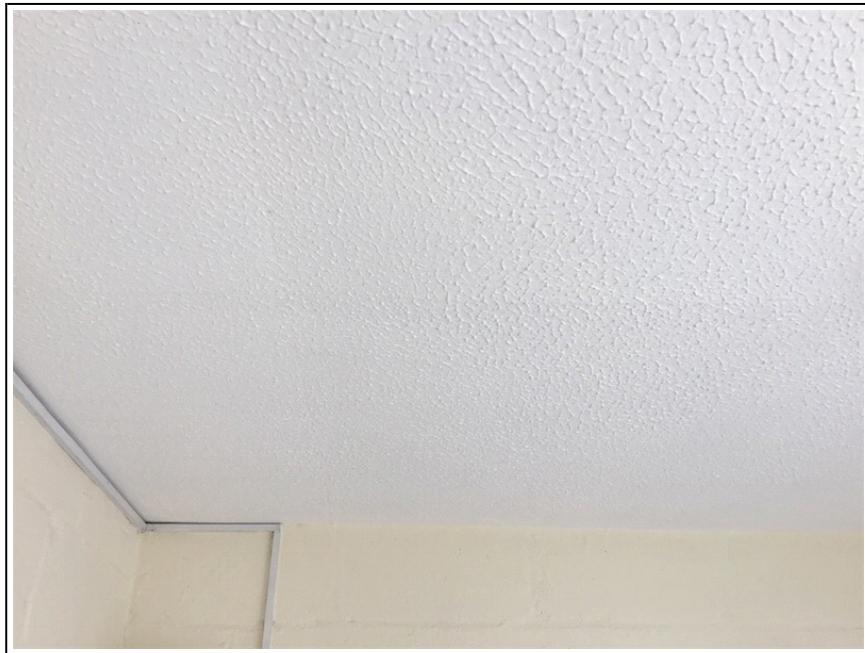
Survey Data Sheet: Conclusions & Recommendations  
 Site Location: 23- 34 Amber Court 3 (Communal Areas), Swindon, SN1 2HB  
 Building Designation: Building 01  
 Unique item Number: 1

Sample Ref	Fl	Location	Description	Qty	Analysis Result	Total M.A.S	Licensed Material Y/N
AN008115	Ground Floor	G.01 - Entrance Hall	Ceiling - Textured coating - Textured Coating	5m <sup>2</sup>	NADIS		N/A

No asbestos detected in sample

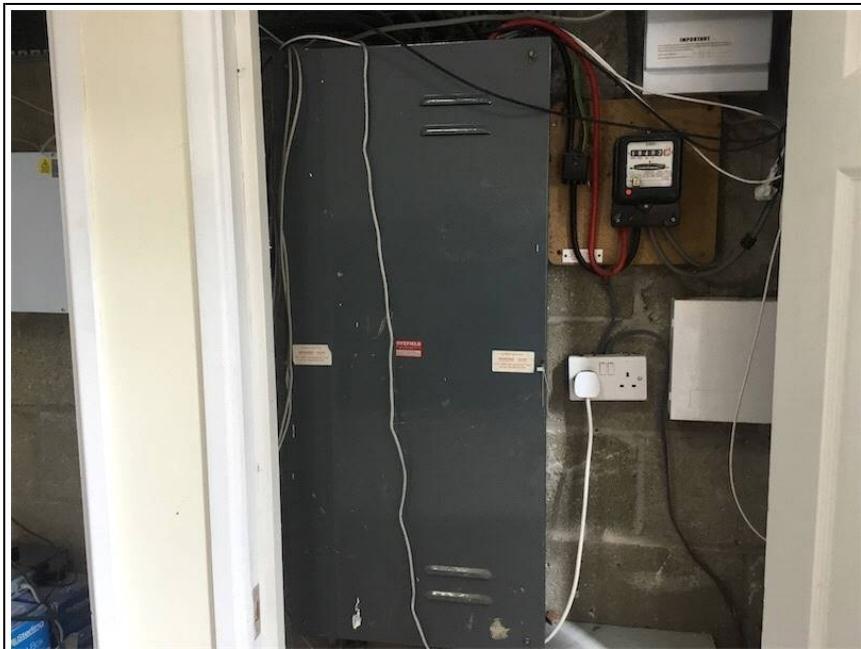
Survey Data Sheet: Conclusions & Recommendations  
 Site Location: 23- 34 Amber Court 3 (Communal Areas), Swindon, SN1 2HB  
 Building Designation: Building 01  
 Unique item Number: 2

Sample Ref	Fl	Location	Description	Qty	Analysis Result	Total M.A.S	Licensed Material Y/N
Presumed	Ground Floor	G.02 - Electrical Cupboard	Within electrical distribution box - Textiles - Asbestos Textiles/Paper	1no.	Crocidolite (or unknown)	7	N

Product Type	Extent of Damage	Surface Treatment	Asbestos Type	Total M.A.S	Accessibility/ Vulnerability	Combined Total for Advised Timescale
2	0	2	3	7	0	7

Recommended Action:	
Investigate Further

The surveyor presumes this material to contain asbestos. This material may remain in situ and be managed accordingly however further investigation must take place before any work is carried out in this area. Meantime no drilling, cutting or any abrasive actions should take place on this material.

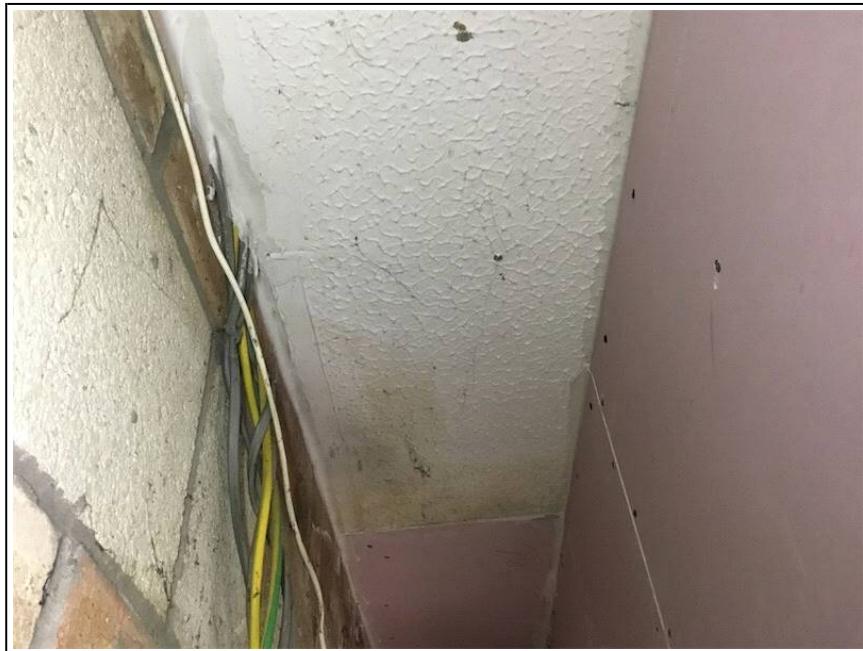
Survey Data Sheet: Conclusions & Recommendations  
 Site Location: 23- 34 Amber Court 3 (Communal Areas), Swindon, SN1 2HB  
 Building Designation: Building 01  
 Unique item Number: 3

Sample Ref	Fl	Location	Description	Qty	Analysis Result	Total M.A.S	Licensed Material Y/N
REFER (AN008115)	Ground Floor	G.02 - Electrical Cupboard	Ceiling - Textured coating - Textured Coating	0.5m <sup>2</sup>	NADIS		N/A

No asbestos detected in sample

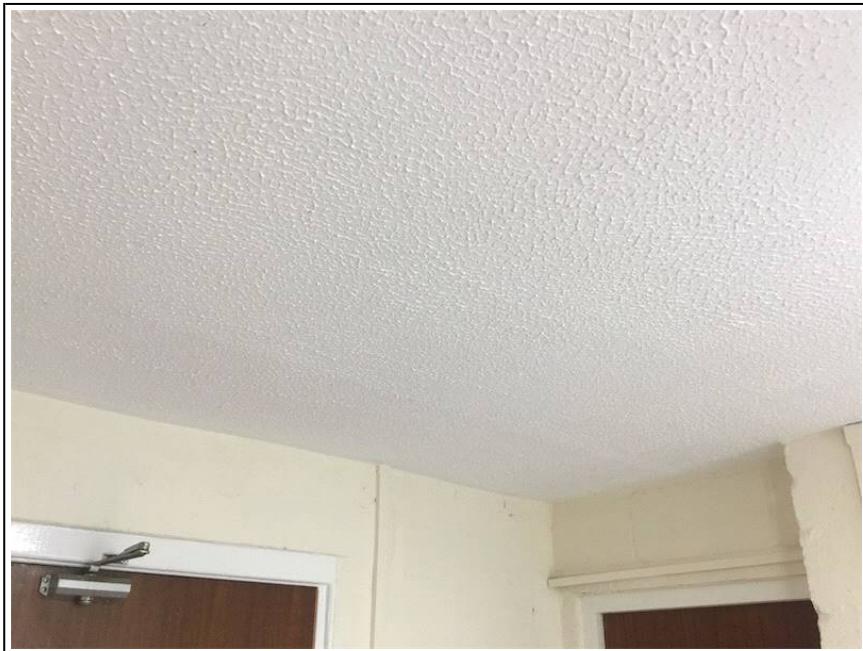
Survey Data Sheet: Conclusions & Recommendations  
 Site Location: 23- 34 Amber Court 3 (Communal Areas), Swindon, SN1 2HB  
 Building Designation: Building 01  
 Unique item Number: 4

Sample Ref	Fl	Location	Description	Qty	Analysis Result	Total M.A.S	Licensed Material Y/N
REFER (AN008115)	Ground Floor	G.03 - Inner Hall	Ceiling - Textured coating - Textured Coating	8m <sup>2</sup>	NADIS		N/A

No asbestos detected in sample

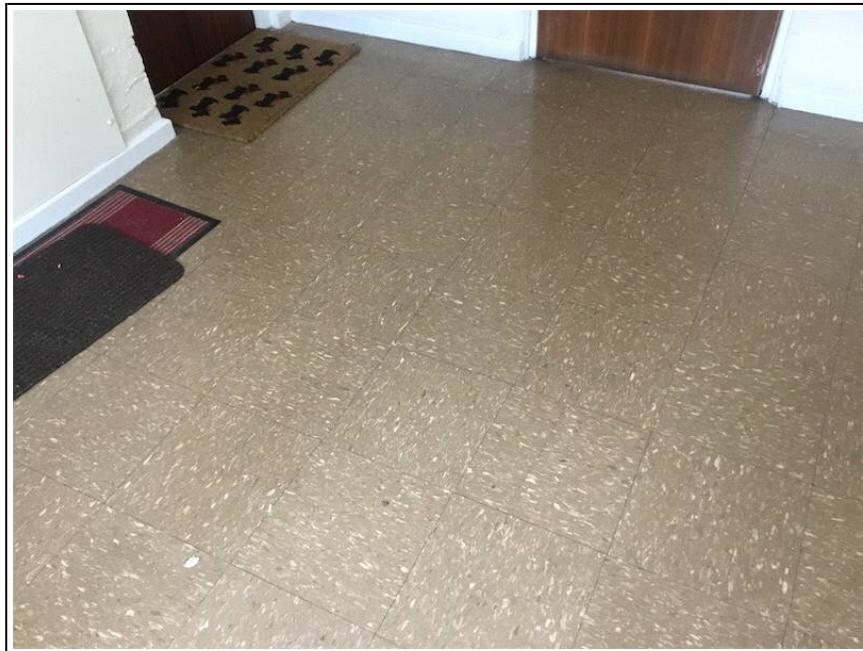
Survey Data Sheet: Conclusions & Recommendations  
 Site Location: 23- 34 Amber Court 3 (Communal Areas), Swindon, SN1 2HB  
 Building Designation: Building 01  
 Unique item Number: 5

Sample Ref	Fl	Location	Description	Qty	Analysis Result	Total M.A.S	Licensed Material Y/N
AN008116	Ground Floor	G.03 - Inner Hall	Floor - Vinyl tiles & bitumen adhesive - Well Bound Material	8m <sup>2</sup>	NADIS		N/A

No asbestos detected in sample

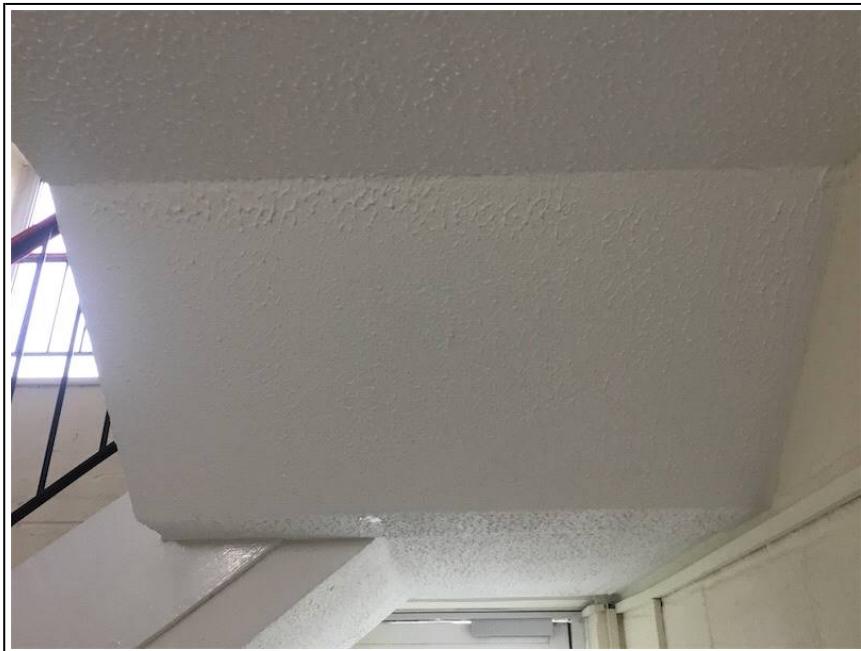
Survey Data Sheet: Conclusions & Recommendations  
 Site Location: 23- 34 Amber Court 3 (Communal Areas), Swindon, SN1 2HB  
 Building Designation: Building 01  
 Unique item Number: 6

Sample Ref	Fl	Location	Description	Qty	Analysis Result	Total M.A.S	Licensed Material Y/N
REFER (AN008115)	Ground Floor	G.04 - Staiwell	Ceiling/ back of stairs - Textured coating - Textured Coating	7m <sup>2</sup>	NADIS		N/A

No asbestos detected in sample

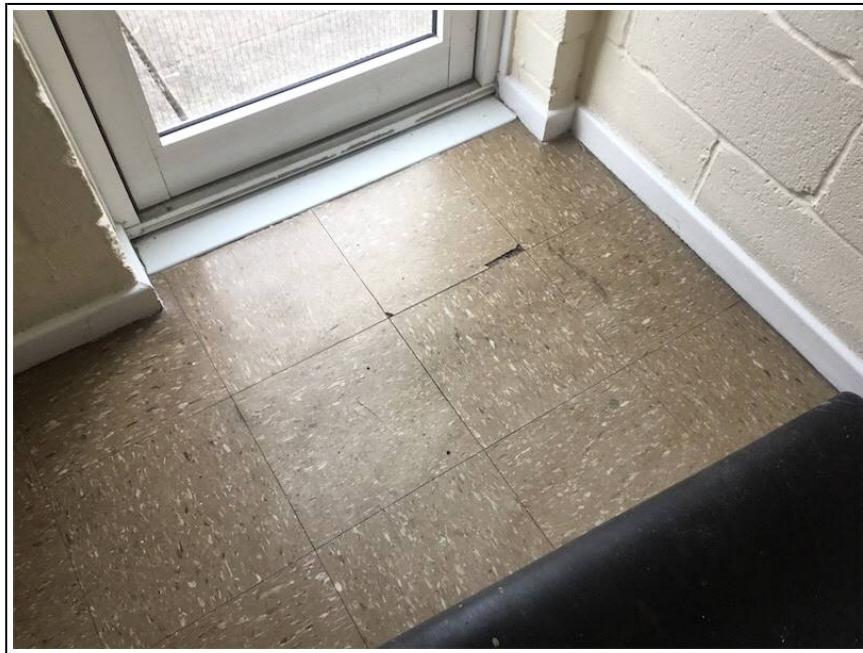
Survey Data Sheet: Conclusions & Recommendations  
 Site Location: 23- 34 Amber Court 3 (Communal Areas), Swindon, SN1 2HB  
 Building Designation: Building 01  
 Unique item Number: 7

Sample Ref	Fl	Location	Description	Qty	Analysis Result	Total M.A.S	Licensed Material Y/N
REFER (AN008116)	Ground Floor	G.04 - Staiwell	Floor - Vinyl tiles & bitumen ashiese - Well Bound Material	9m <sup>2</sup>	NADIS		N/A

No asbestos detected in sample

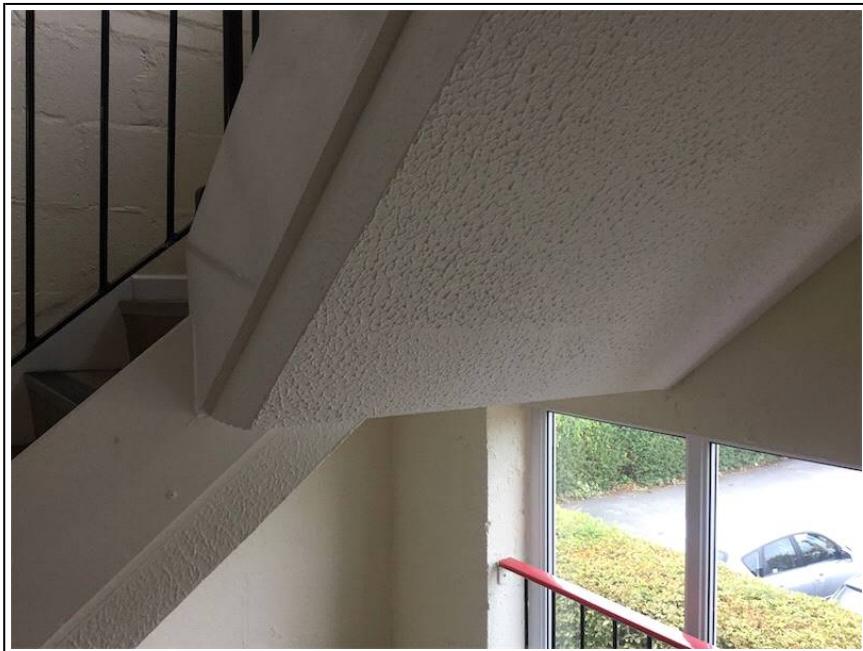
Survey Data Sheet: Conclusions & Recommendations  
 Site Location: 23- 34 Amber Court 3 (Communal Areas), Swindon, SN1 2HB  
 Building Designation: Building 01  
 Unique item Number: 8

Sample Ref	Fl	Location	Description	Qty	Analysis Result	Total M.A.S	Licensed Material Y/N
REFER (AN008115)	1st Floor	1.01 - Landing	Back of stairs - Textured coating - Textured Coating	11m	NADIS		N/A

No asbestos detected in sample

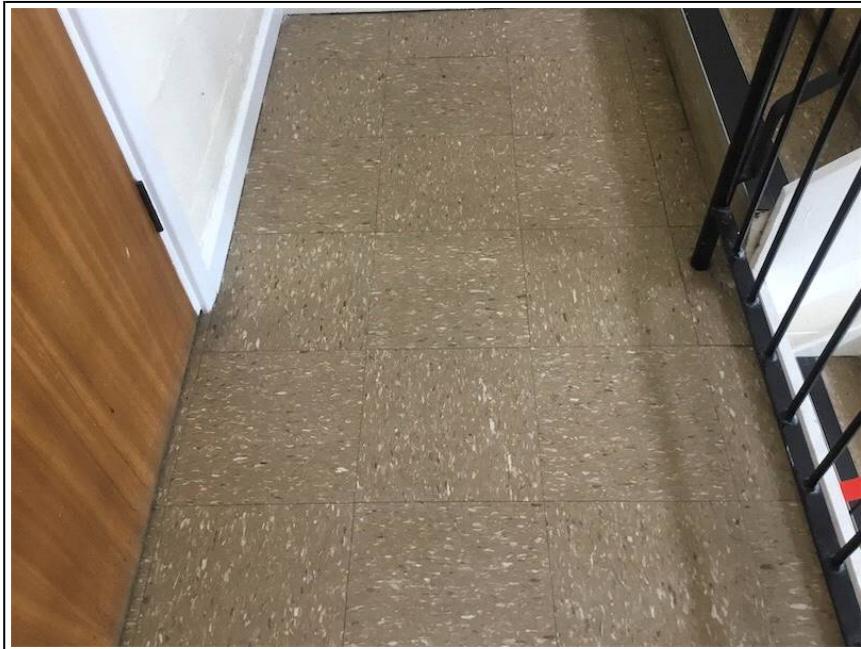
Survey Data Sheet: Conclusions & Recommendations  
 Site Location: 23- 34 Amber Court 3 (Communal Areas), Swindon, SN1 2HB  
 Building Designation: Building 01  
 Unique item Number: 9

Sample Ref	Fl	Location	Description	Qty	Analysis Result	Total M.A.S	Licensed Material Y/N
REFER (AN008116)	1st Floor	1.01 - Landing	Floor - Vinyl tiles & bitumen adhesive - Well Bound Material	4m <sup>2</sup>	NADIS		N/A

No asbestos detected in sample

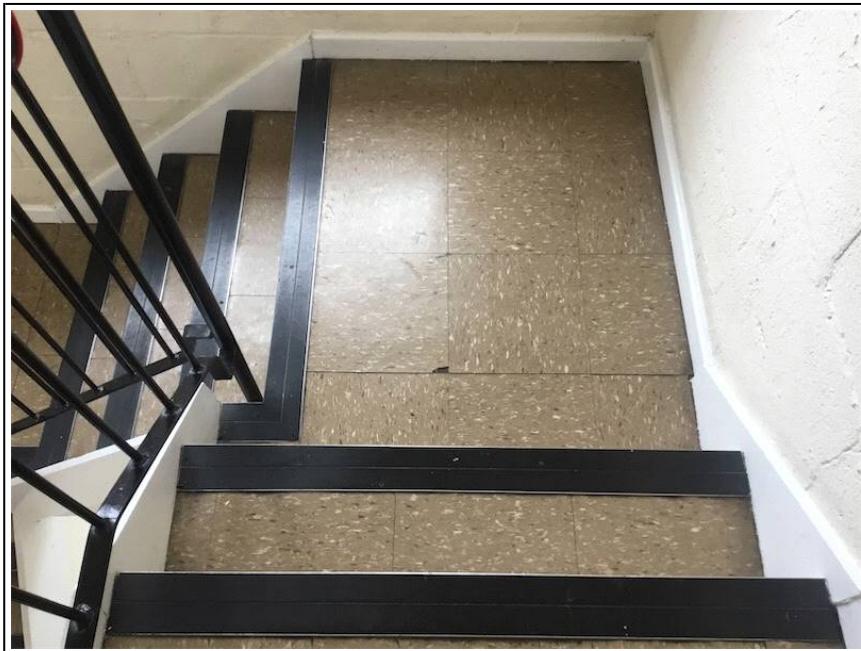
Survey Data Sheet: Conclusions & Recommendations  
 Site Location: 23- 34 Amber Court 3 (Communal Areas), Swindon, SN1 2HB  
 Building Designation: Building 01  
 Unique item Number: 10

Sample Ref	Fl	Location	Description	Qty	Analysis Result	Total M.A.S	Licensed Material Y/N
REFER (AN008116)	1st Floor	1.01 - Landing	Stairs - Vinyl tiles & bitumen adhesive - Well Bound Material	7m <sup>2</sup>	NADIS		N/A

No asbestos detected in sample

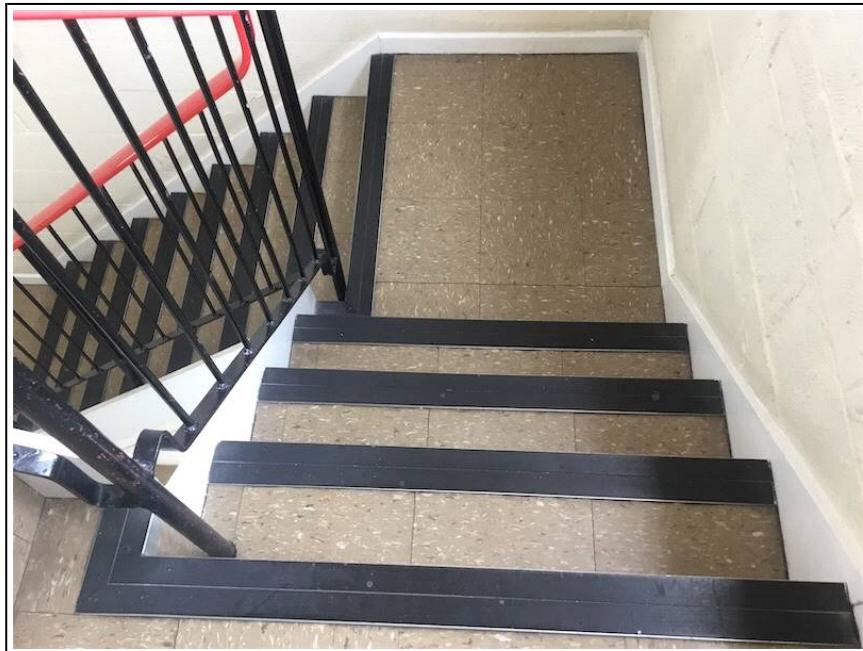
Survey Data Sheet: Conclusions & Recommendations  
 Site Location: 23- 34 Amber Court 3 (Communal Areas), Swindon, SN1 2HB  
 Building Designation: Building 01  
 Unique item Number: 11

Sample Ref	Fl	Location	Description	Qty	Analysis Result	Total M.A.S	Licensed Material Y/N
AN008117	1st Floor	1.01 - Landing	Stairs - Nosing - Well Bound Material	14no.	NADIS		N/A

No asbestos detected in sample

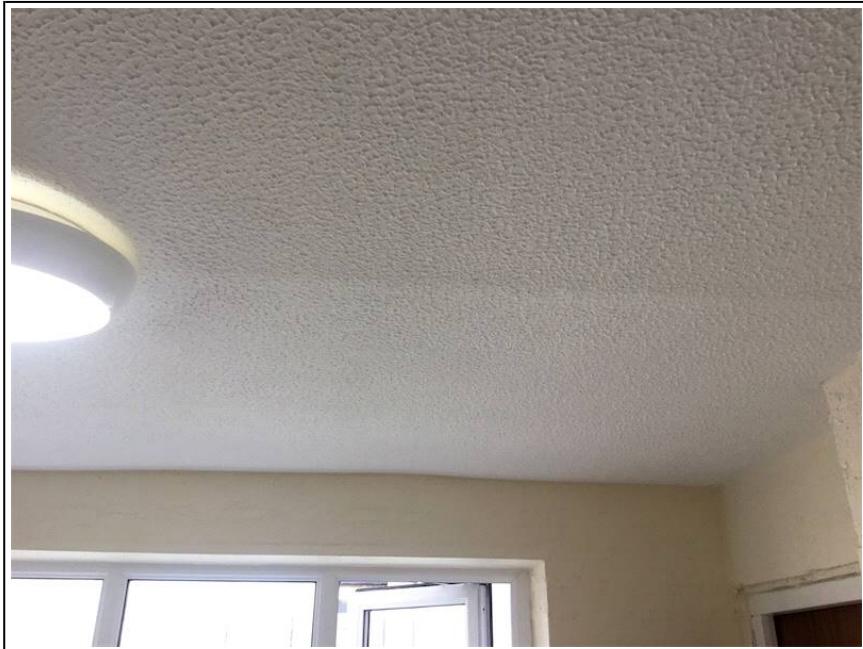
Survey Data Sheet: Conclusions & Recommendations  
 Site Location: 23- 34 Amber Court 3 (Communal Areas), Swindon, SN1 2HB  
 Building Designation: Building 01  
 Unique item Number: 12

Sample Ref	Fl	Location	Description	Qty	Analysis Result	Total M.A.S	Licensed Material Y/N
REFER (AN008115)	1st Floor	1.02 - Hall	Ceiling - Textured coating - Textured Coating	8m <sup>2</sup>	NADIS		N/A

No asbestos detected in sample

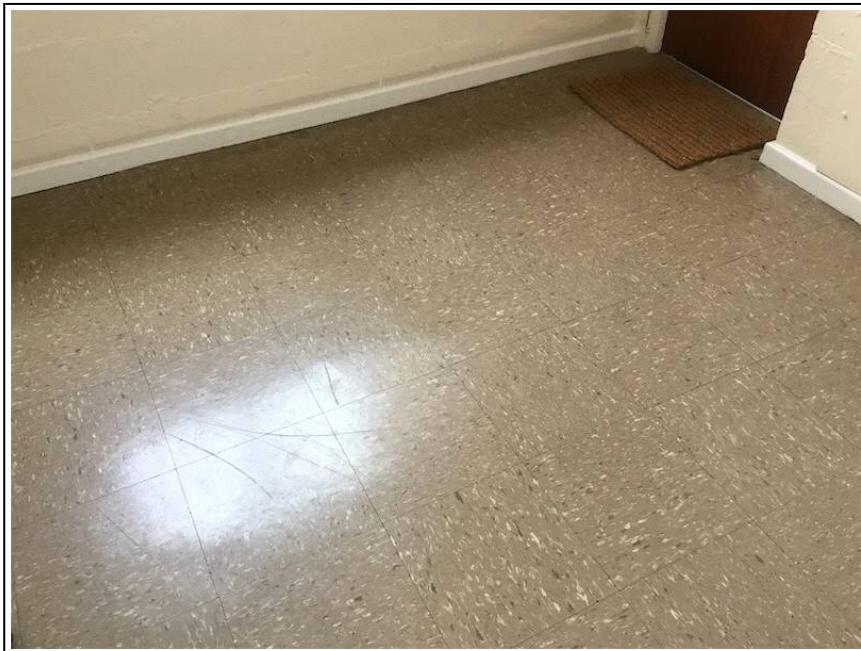
Survey Data Sheet: Conclusions & Recommendations  
 Site Location: 23- 34 Amber Court 3 (Communal Areas), Swindon, SN1 2HB  
 Building Designation: Building 01  
 Unique item Number: 13

Sample Ref	Fl	Location	Description	Qty	Analysis Result	Total M.A.S	Licensed Material Y/N
REFER (AN008116)	1st Floor	1.02 - Hall	Floor - Vinyl tiles & bitumen adhesive - Well Bound Material	8m <sup>2</sup>	NADIS		N/A

No asbestos detected in sample

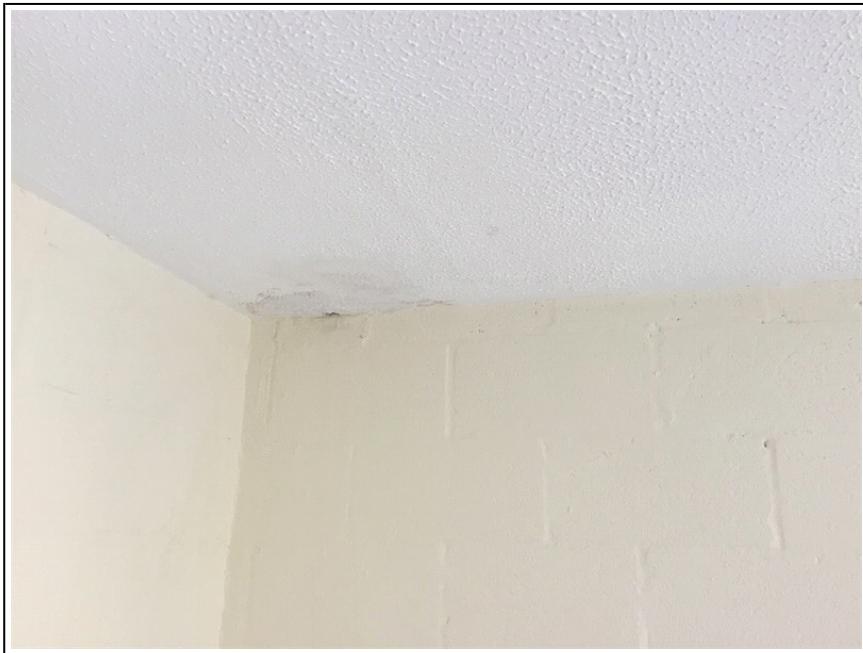
Survey Data Sheet: Conclusions & Recommendations  
 Site Location: 23- 34 Amber Court 3 (Communal Areas), Swindon, SN1 2HB  
 Building Designation: Building 01  
 Unique item Number: 14

Sample Ref	Fl	Location	Description	Qty	Analysis Result	Total M.A.S	Licensed Material Y/N
REFER (AN008115)	2nd Floor	2.01 - Landing	Ceiling - Textured coating - Textured Coating	12m <sup>2</sup>	NADIS		N/A

No asbestos detected in sample

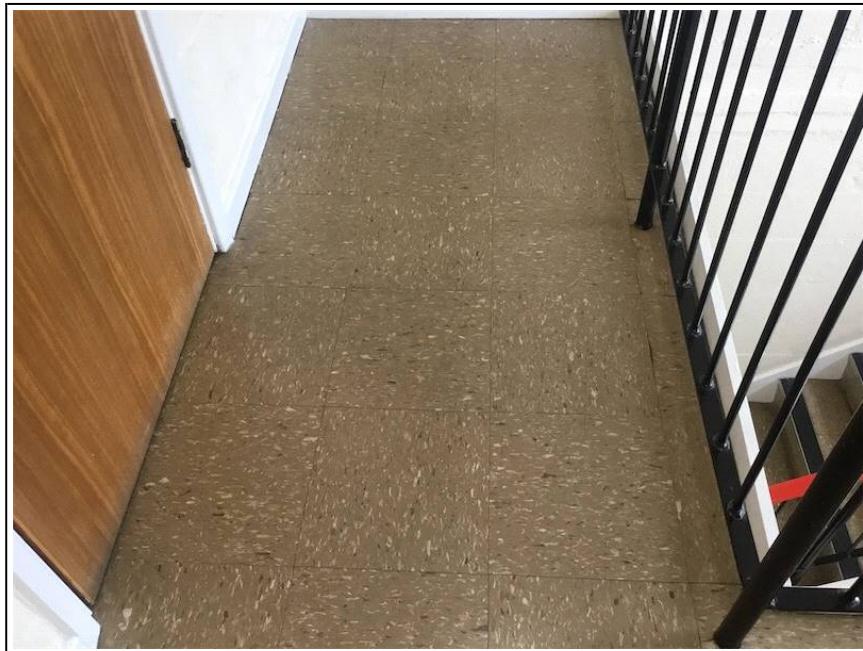
Survey Data Sheet: Conclusions & Recommendations  
 Site Location: 23- 34 Amber Court 3 (Communal Areas), Swindon, SN1 2HB  
 Building Designation: Building 01  
 Unique item Number: 15

Sample Ref	Fl	Location	Description	Qty	Analysis Result	Total M.A.S	Licensed Material Y/N
REFER (AN008116)	2nd Floor	2.01 - Landing	Floor - Vinyl tiles & bitumen adhesive - Well Bound Material	4m <sup>2</sup>	NADIS		N/A

No asbestos detected in sample

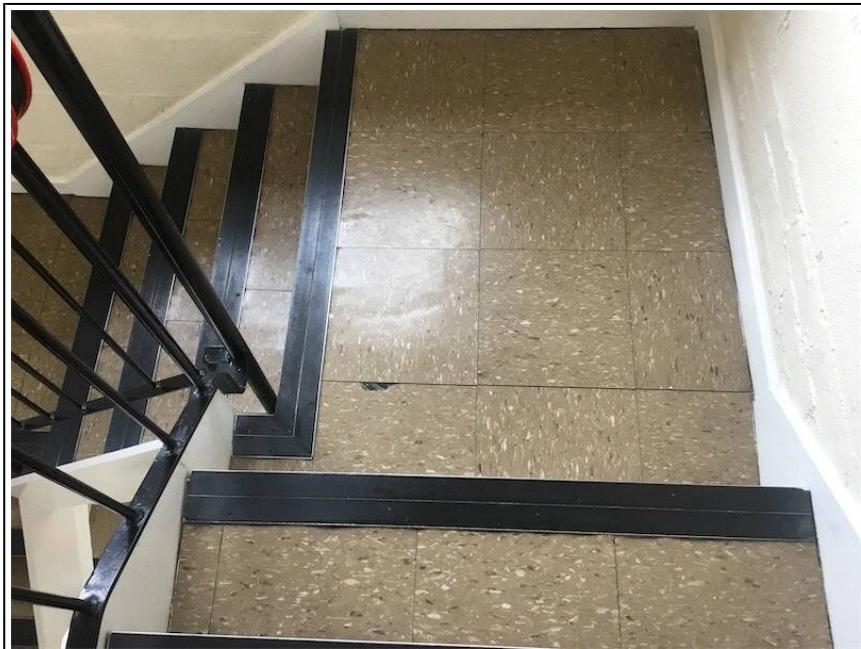
Survey Data Sheet: Conclusions & Recommendations  
 Site Location: 23- 34 Amber Court 3 (Communal Areas), Swindon, SN1 2HB  
 Building Designation: Building 01  
 Unique item Number: 16

Sample Ref	Fl	Location	Description	Qty	Analysis Result	Total M.A.S	Licensed Material Y/N
REFER (AN008116)	2nd Floor	2.01 - Landing	Stairs - Vinyl tiles & bitumen adhesive - Well Bound Material	7m <sup>2</sup>	NADIS		N/A

No asbestos detected in sample

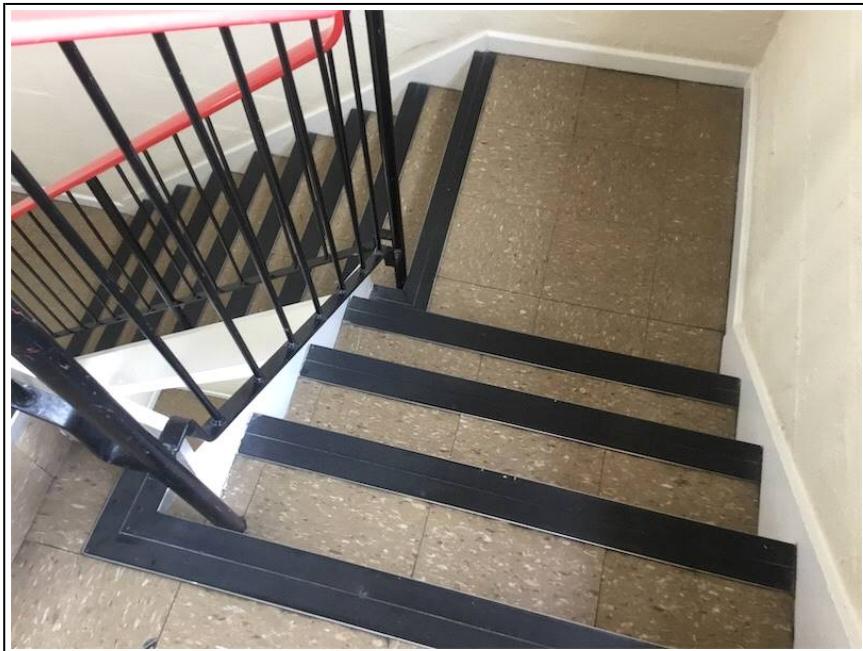
Survey Data Sheet: Conclusions & Recommendations  
 Site Location: 23- 34 Amber Court 3 (Communal Areas), Swindon, SN1 2HB  
 Building Designation: Building 01  
 Unique item Number: 17

Sample Ref	Fl	Location	Description	Qty	Analysis Result	Total M.A.S	Licensed Material Y/N
REFER (AN008117)	2nd Floor	2.01 - Landing	Stairs - Nosing - Well Bound Material	14no.	NADIS		N/A

No asbestos detected in sample

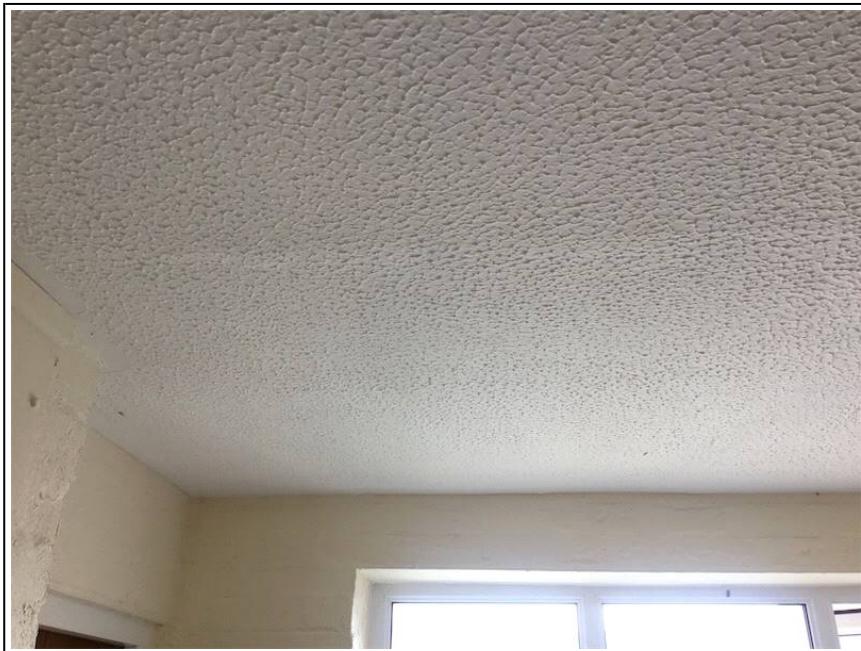
Survey Data Sheet: Conclusions & Recommendations  
 Site Location: 23- 34 Amber Court 3 (Communal Areas), Swindon, SN1 2HB  
 Building Designation: Building 01  
 Unique item Number: 18

Sample Ref	Fl	Location	Description	Qty	Analysis Result	Total M.A.S	Licensed Material Y/N
REFER (AN008115)	2nd Floor	2.02 - Hall	Ceiling - Textured coating - Textured Coating	8m <sup>2</sup>	NADIS		N/A

No asbestos detected in sample

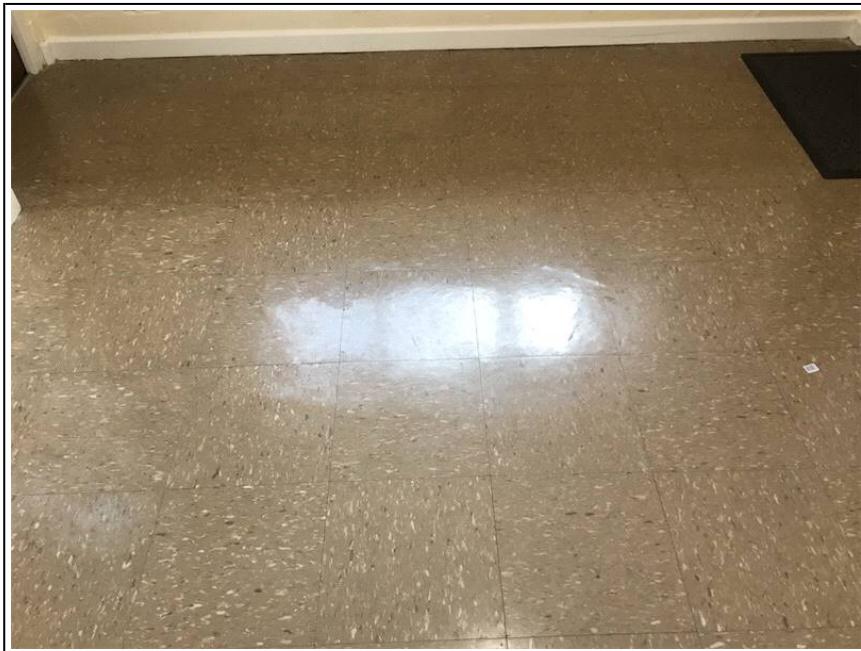
Survey Data Sheet: Conclusions & Recommendations  
 Site Location: 23- 34 Amber Court 3 (Communal Areas), Swindon, SN1 2HB  
 Building Designation: Building 01  
 Unique item Number: 19

Sample Ref	Fl	Location	Description	Qty	Analysis Result	Total M.A.S	Licensed Material Y/N
REFER (AN008116)	2nd Floor	2.02 - Hall	Floor - Vinyl tiles & bitumen adhesive - Well Bound Material	8m <sup>2</sup>	NADIS		N/A

No asbestos detected in sample

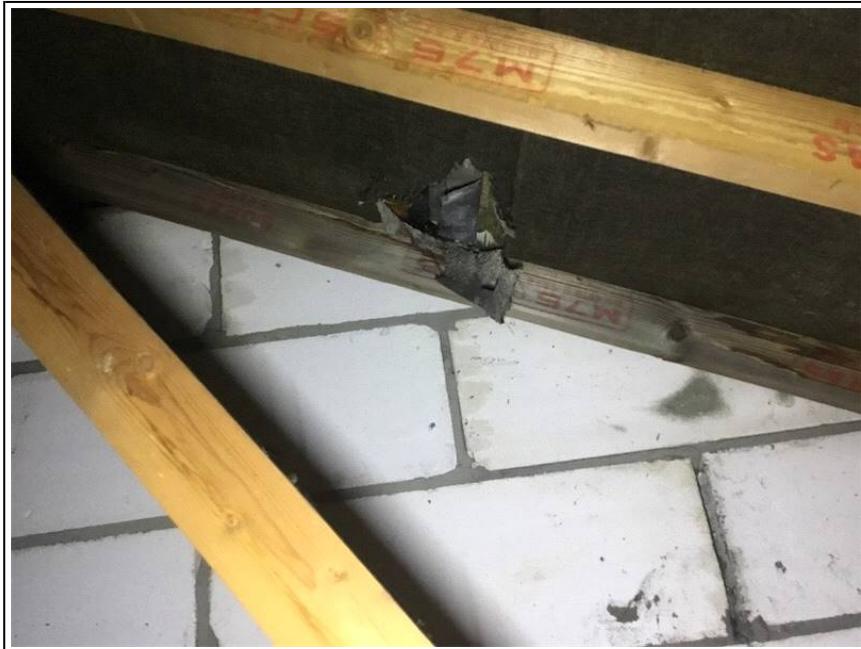
Survey Data Sheet: Conclusions & Recommendations  
 Site Location: 23- 34 Amber Court 3 (Communal Areas), Swindon, SN1 2HB  
 Building Designation: Building 01  
 Unique item Number: 20

Sample Ref	Fl	Location	Description	Qty	Analysis Result	Total M.A.S	Licensed Material Y/N
AN008118	Roof Void	Attic	Inner roof - Underfelt - Well Bound Material	16m <sup>2</sup>	NADIS		N/A

No asbestos detected in sample

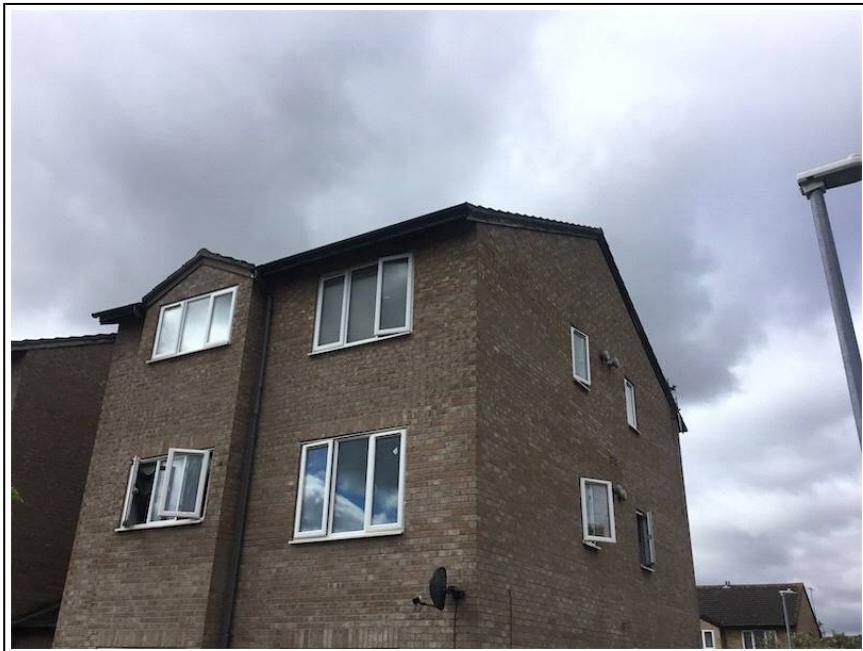
Survey Data Sheet: Conclusions & Recommendations  
 Site Location: 23- 34 Amber Court 3 (Communal Areas), Swindon, SN1 2HB  
 Building Designation: Building 01  
 Unique item Number: 21

Sample Ref	Fl	Location	Description	Qty	Analysis Result	Total M.A.S	Licensed Material Y/N
Presumed	External	External	Roof - Undercloak - Asbestos Cement	60m	Crocidolite (or unknown)	5	N

Recommended Action:
Investigate Further
