# Asbestos Management Survey Report

23- 34 Amber Court 3 (Communal Areas), Swindon, SN1 2HB

**SWINDON ASBESTOS SURVEYING LTD**

Date of Survey:	24 Aug 2022
Date of Report:	5 Sep 2022
Job No:	<u>J011787</u>
Authorising Surveyor:	Jim Hook
Verified/Signature:

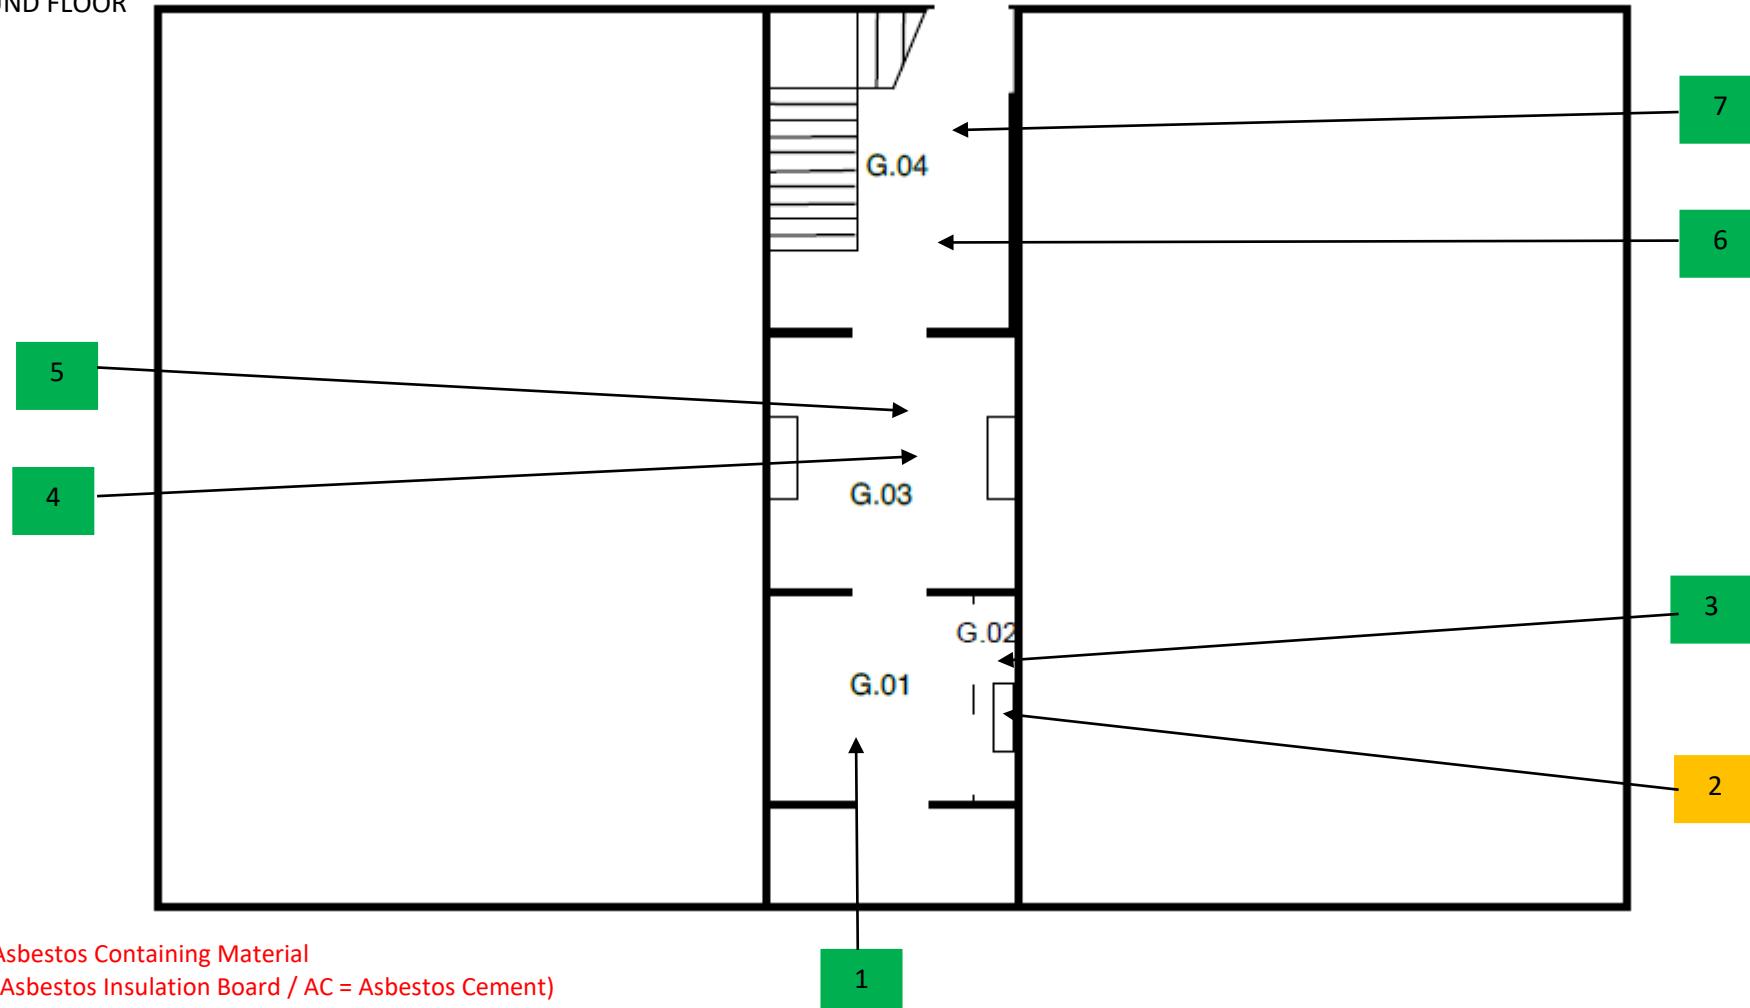
GROUND FLOOR

Fl	Building Designation	Location	Asbestos Containing Material	M.A.S	Recommended Action
Gr	Building 01	G.02 - Electrical Cupboard	Within electrical distribution box - Textiles - Asbestos Textiles/Paper	7	Investigate Further
Ex	Building 01	External	Roof - Undercloak - Asbestos Cement	5	Investigate Further
