# COMBINED FIRE AND HEALTH & SAFETY RISK ASSESSMENT.

Address of premises:	Amber Court 3 (23-34), Swindon, SN1 2HB
Responsible Person:	Amber Court Management (No 3) Limited
Duty Holder:	Block Management Limited
Person(s) consulted:	No occupier or other relevant person available to consult.
Assessor:	Rob Cockburn
Report validated by:	John Godfrey, GIfireE.
Date of fire risk assessment:	19 <sup>th</sup> September 2024/ September 2025
Date of previous fire risk assessment:	September 2022
Suggested date for review:	September 2026

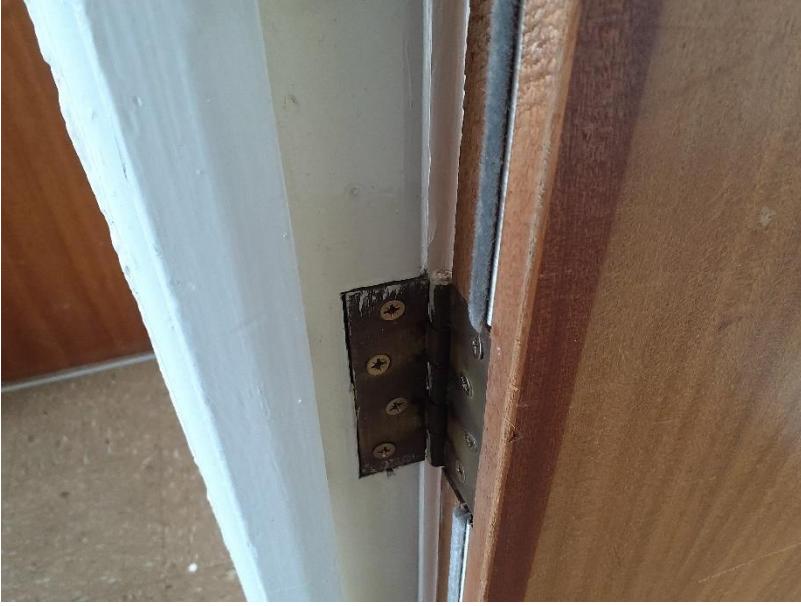
It was noted during this fire risk assessment that all lobby doors within the premises were hung on three non-fire rated hinges which could affect the integrity of the door during high temperatures. It is therefore recommended that the RP instructs a suitably qualified and competent contractor to upgrade the hinges on all lobby doors to high temperature grade 13 hinges.

04	<p>It was noted during this fire risk assessment that all lobby doors within the premises were hung on three non-fire rated hinges which could affect the integrity of the door during high temperatures. It is therefore recommended that the RP instructs a suitably qualified and competent contractor to upgrade the hinges on all lobby doors to high temperature grade 13 hinges.</p>

3	B		<p>Ongoing action required</p> <p>Upgrades to be considered by RP.</p>
05	<p>It was noted during this fire risk assessment that the frame on the second-floor lobby door to the staircase was split which could affect the integrity of the fire resistance. It is recommended that the RP instructs a suitably qualified and competent contractor to repair the frame in order to stop the spread of smoke and fire into the means of escape.</p>

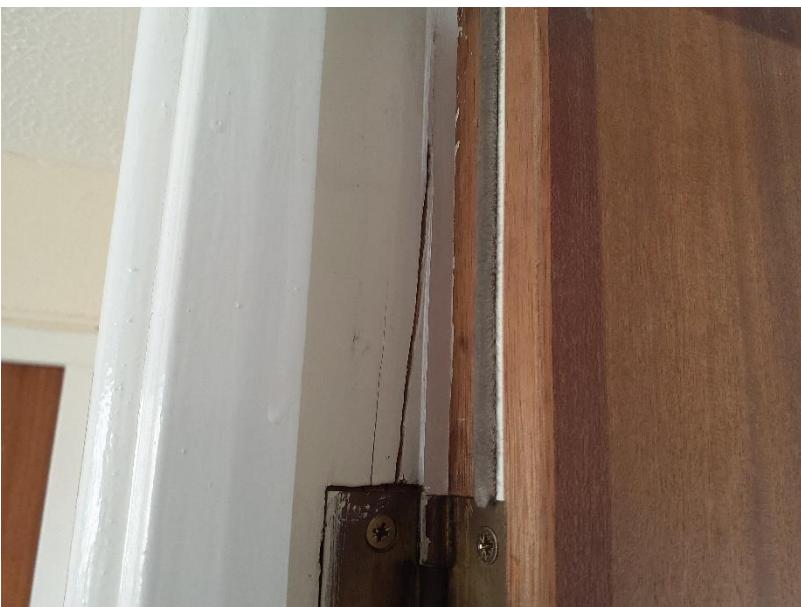
It was noted during this fire risk assessment that the frame on the second-floor lobby door to the staircase was split which could affect the integrity of the fire resistance. It is recommended that the RP instructs a suitably qualified and competent contractor to repair the frame in order to stop the spread of smoke and fire into the means of escape.

2	B		<p>Action complete</p>

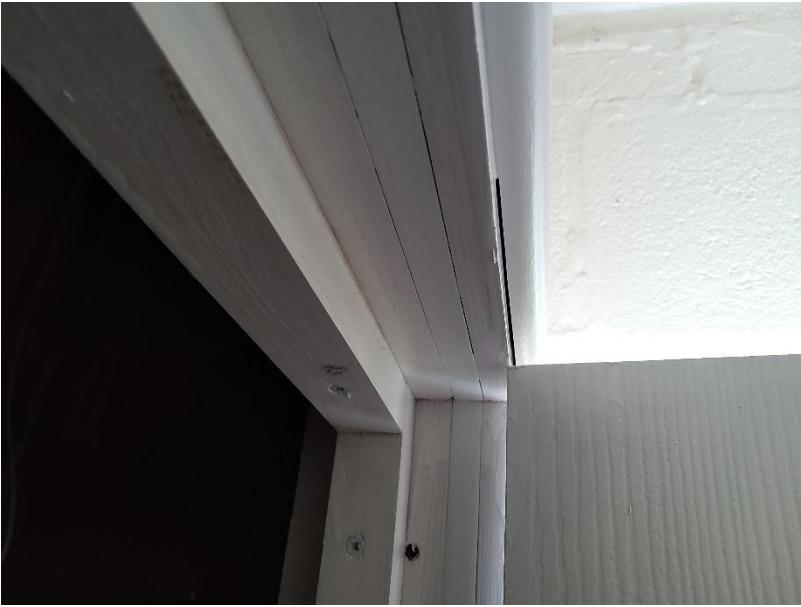
It was noted during this fire risk assessment that the intake cupboard doors had intumescent seals only. It is recommended that the RP instructs a suitably qualified and competent contractor to install cold smoke seals to compliment the intumescent seals in order to protect the means of escape from smoke.

06	<p>It was noted during this fire risk assessment that the intake cupboard doors had intumescent seals only. It is recommended that the RP instructs a suitably qualified and competent contractor to install cold smoke seals to compliment the intumescent seals in order to protect the means of escape from smoke.</p>

3	B	Action complete
----	---	---	---	-----------------

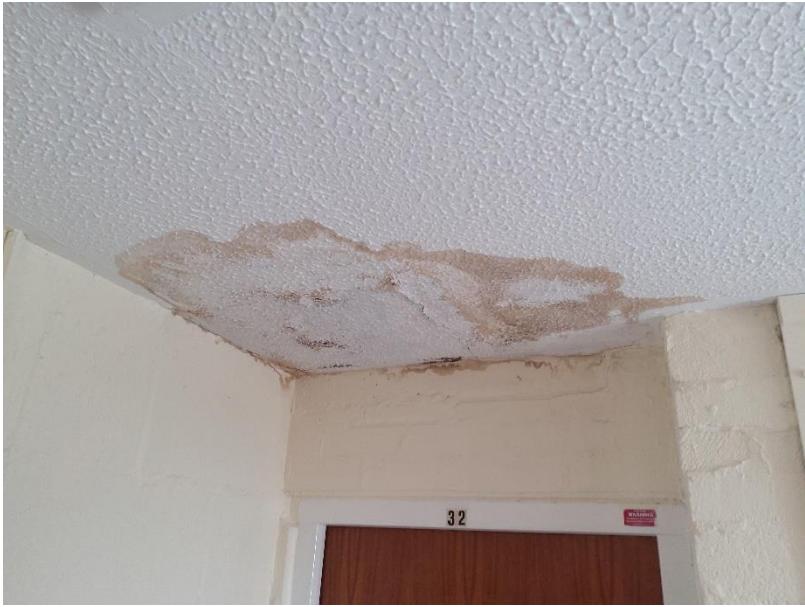
09	<p>It was noted during this fire risk assessment that there was water damage on the ceiling within the second-floor lobby. It could not be determined if this has affected the integrity of the compartmentation between the communal areas and the roof/flat. It is therefore recommended that the RP instructs a suitably qualified and competent contractor to investigate further, any deficiencies found should be actioned as a priority in order to protect the means of escape.</p>

1	B	<p>Action complete To be monitored</p>
10	<p>Each flat is responsible for their own fire precautions and it is recommended that the RP advise each resident of the importance of installing smoke detectors within their flat. One battery operated smoke detector in the lobby of each flat would be the minimum provision, however mains powered smoke detectors, each with a battery backup, installed within the escape route of each flat, in all rooms that communicate with the escape route and a heat detector within the kitchen, interlinked to form a BS5839-6: 2019 Grade D detection system with LD2 coverage would be the preferred and safest option for each occupant.</p>	3	C	<p>Ongoing action required DH provide fire safety notice to owners annually</p>
